Manhole Inspection Summary

Manhole # S53AA_034MH

Insp Date: **7/16/08 3:13 PM**

Location Address: **3300 mcelderry st**

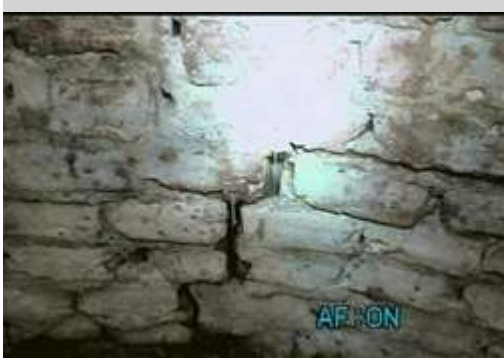
Defect 5

Condition: ☐ Sound ☒ **Cracked** ☐ Root Intrusion ☐ Loose Brick ☐ Deteriorated

chimney cracked

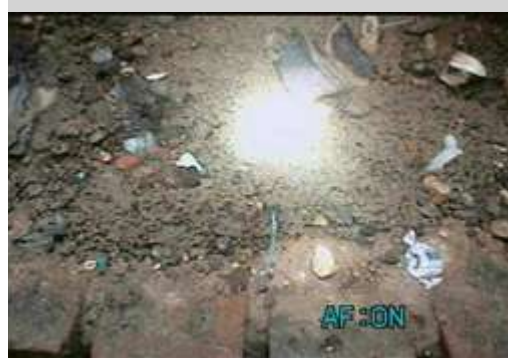
Defect 4

bench debris

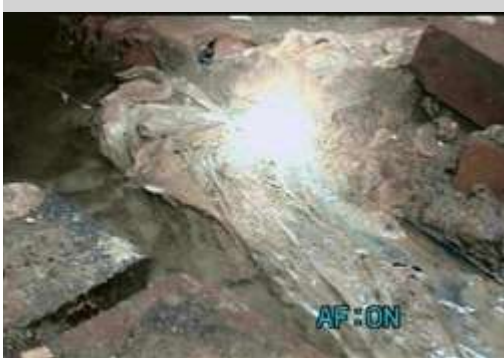
Defect 3

Condition: ☐ Sound ☐ Cracked ☐ Root Intrusion ☐ Deteriorated ☐ Leaks ☒ **Debris**

channel debris and parged

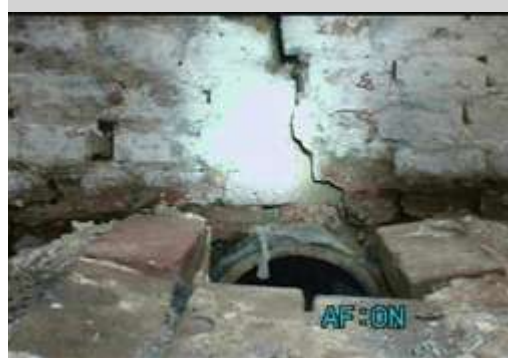
Defect 2

Condition: ☐ Sound ☒ **Cracked** ☐ Root Intrusion ☐ Loose Brick ☐ Deteriorated

barrel cracked and bench deteriorated

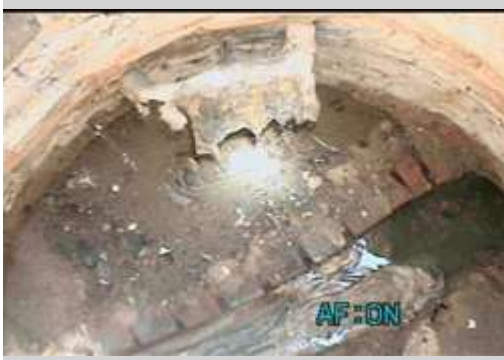
Defect 1

Count: **1** Missing: **0** ☒ **Corroded**

☒ **Evidence Of Surcharge** Depth: **3.** (ft.) ☐ Active Surcharge Present

step & surcharge evd
